**Environmental Condition of Property
to Support Hawaii Public-Private
Venture Housing Phase 4
Marine Corps Base Hawaii Housing Areas:
Mololani, Pa Honua 3, & Ulupau
KANEEOHE BAY, HAWAII**

August 2007

**Environmental Science International
56 Oneawa Street, Suite 103
Kailua, HI 96734**

Contract Number N62742-06-D-1891, CTO 0002

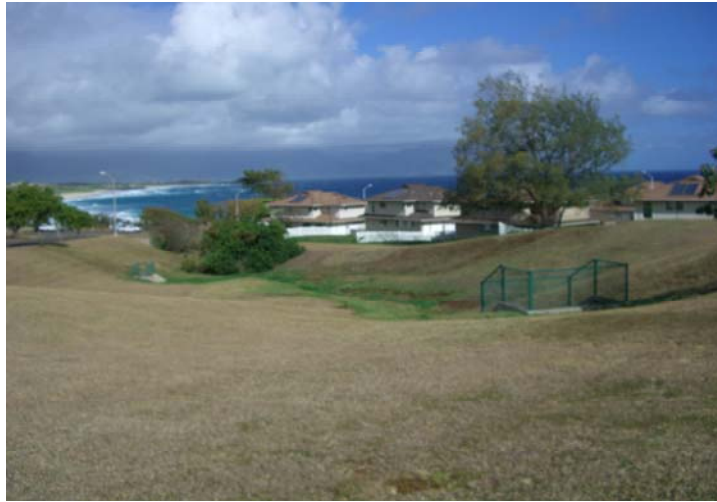
View of the drainage ditch, facing northwest toward Heleloa beach. The discharge location located downgradient and to the west of the surface drain shown in photo2.
